**TEST SUMMARY # 17**

**STRONGBACK COMPOSITE REPAIR  
SYSTEM FOR DAMAGED PIPES**

**CLIENT: BOTAS PETROLEUM PIPELINE CORPORATION**

**DATE: COMMENCED 6/2006. COMPLETE 6/2006.**

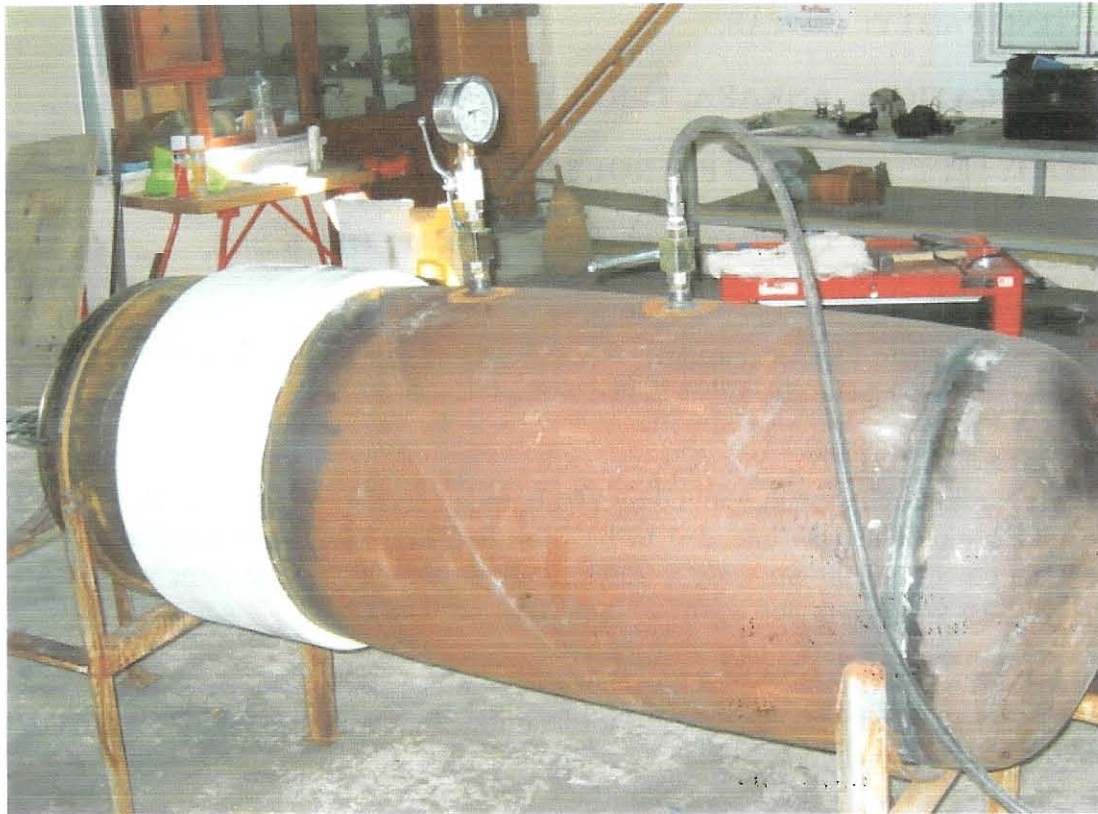
Pipe pressured to the regular pipe test level of 102.5 barg and easily held for 15 minutes. The pressure was gradually increased to 137.5 barg, the limit of the pump. At this pressure deformation of the virgin pipe was clearly visible but the StrongBack reinforced section showed no deformation.

**AT PUMP LIMIT, PRESSURE OF 137.5 BARG REACHED.  
STRONGBACK REPAIR SEEN CONTAINING EXPANSION AS UNWRAPPED  
PORTION OF PIPE SHOWN BALLOONING.**

The defect was filled with the StrongBack load transfer epoxy # GS-154 followed by the epoxy # GS-561 undercoat which was applied over the defect and around the pipe circumference. Five ( 5 ) rolls of StrongBack tape # SB-1290 wrapped over the epoxy, to provide approx. 30 layers.
